Investigation of the Performance of the New Orleans Flood Protection Systems in Hurricane Katrina on August 29, 2005

Volume I: Main Text and Executive Summary

**Final Report
July 31, 2006**

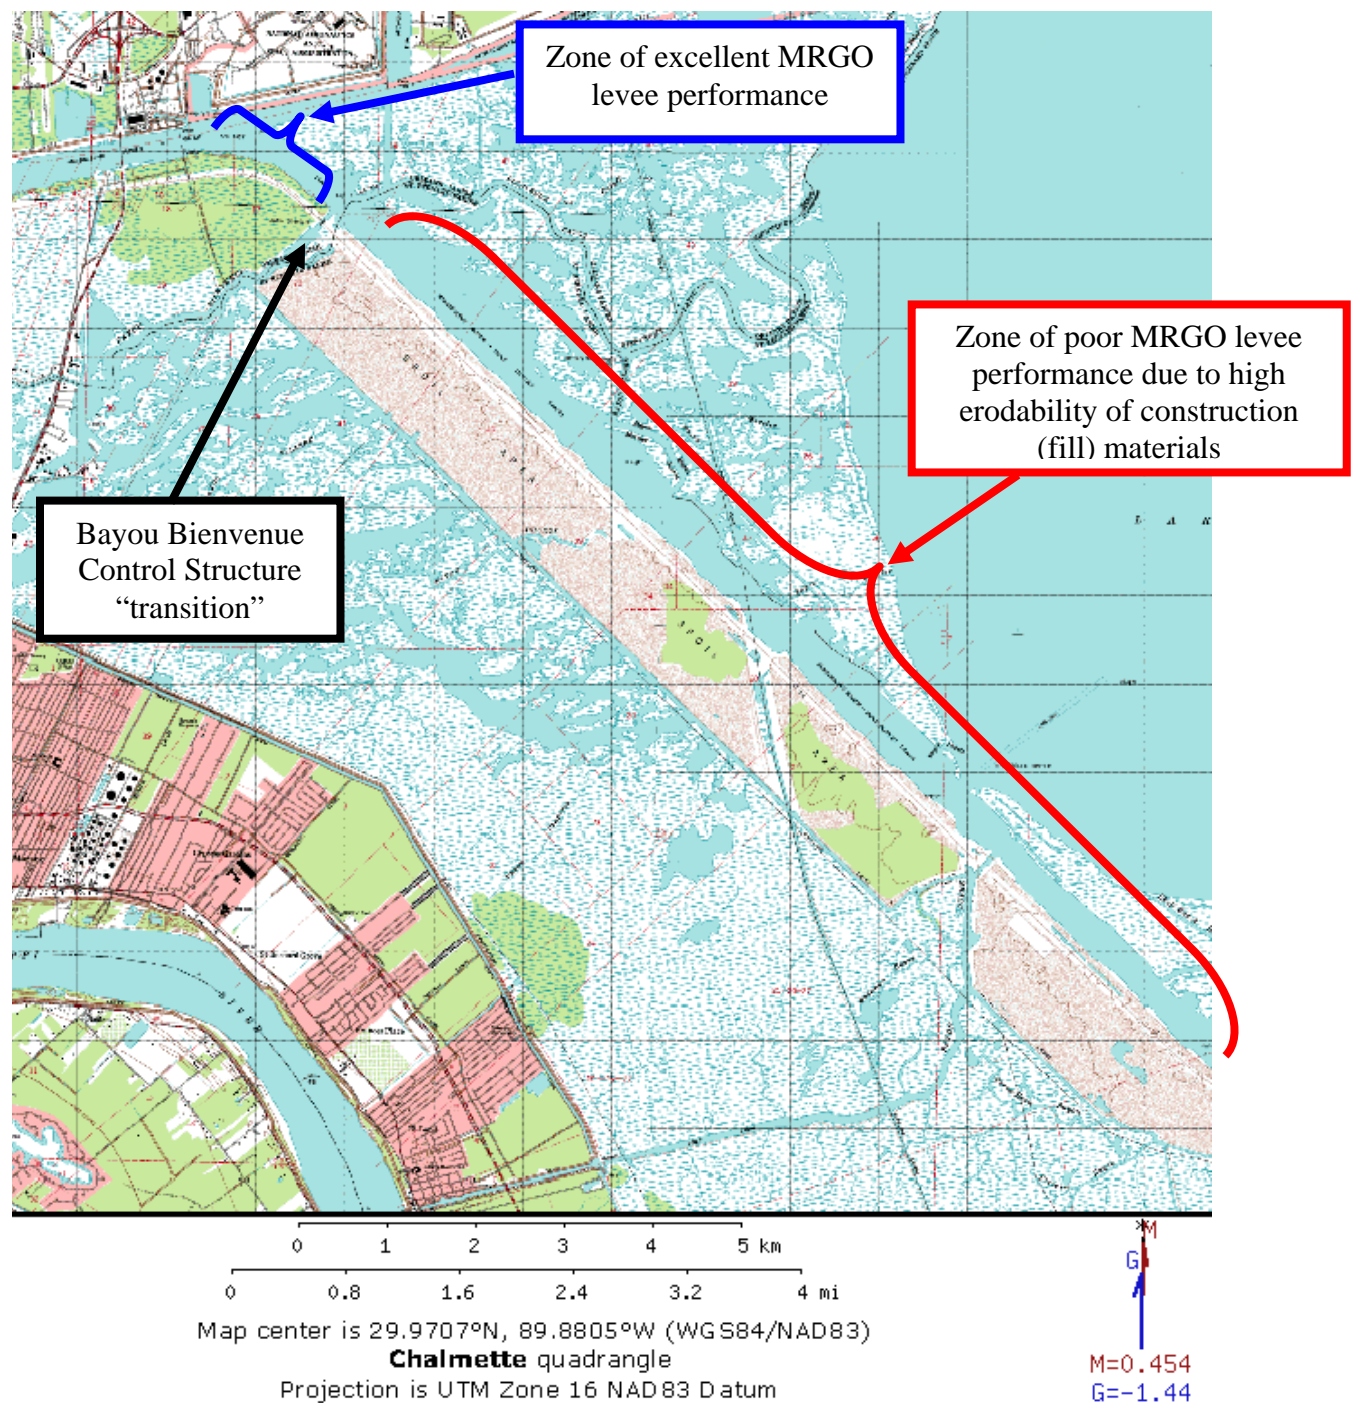
Figure 10.26: A U.S.G.S. topographic map showing the presence of “spoils” along the MRGO. As seen in Figure 10.28, the levee materials to the southeast of the Bayou Bienvenue Control Structure performed poorly.

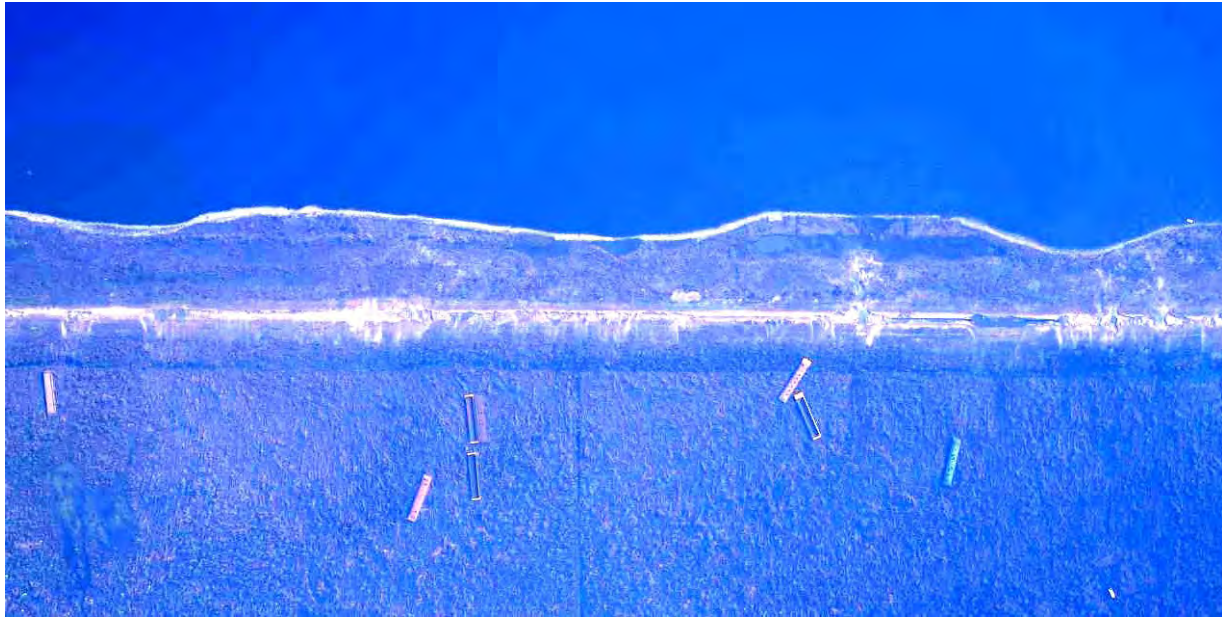
Figure 10.27: Aerial photograph taken by NOAA in early September 2005 along the MRGO showing severe erosion/breaches of the earthen levee and transport and deposition of large barges over the levee as a result of the storm surge (location 8 on Figure 10.6).

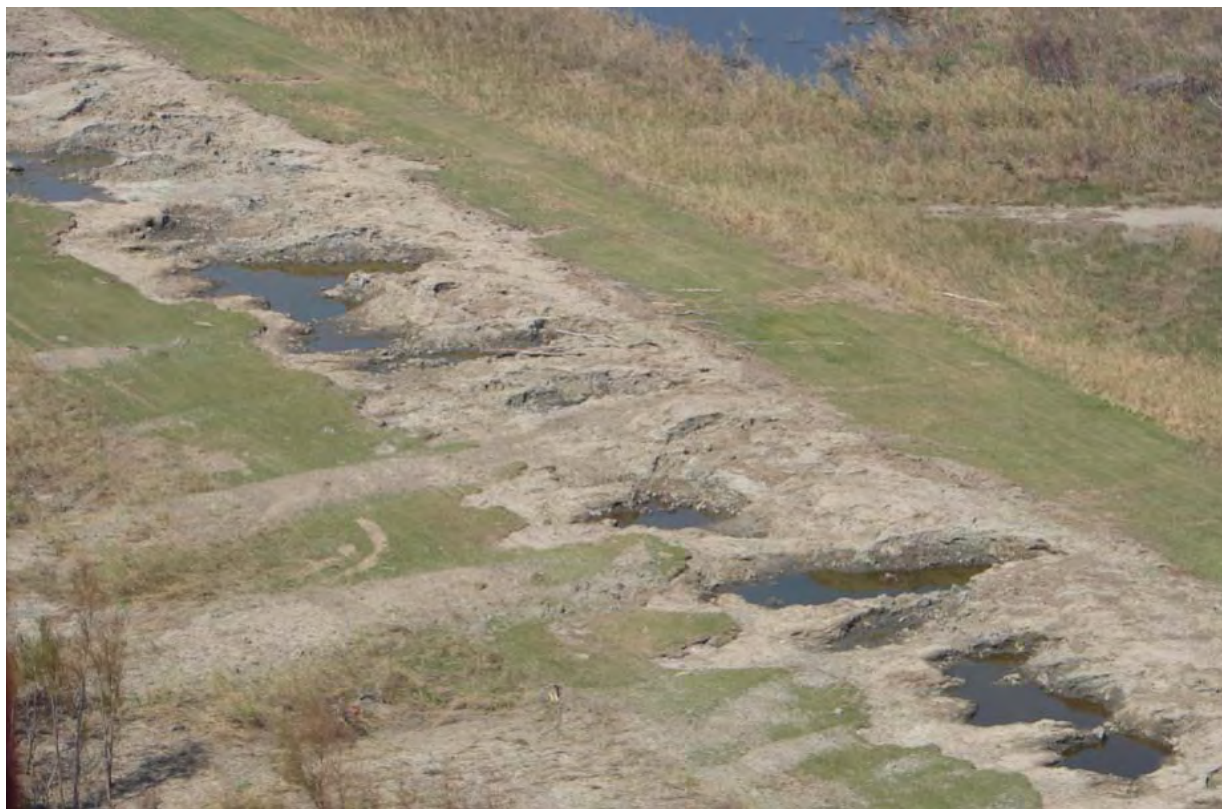
Figure 10.28: Close up aerial photograph of severely eroded MRGO levees at location 8 on Figure 10.6.

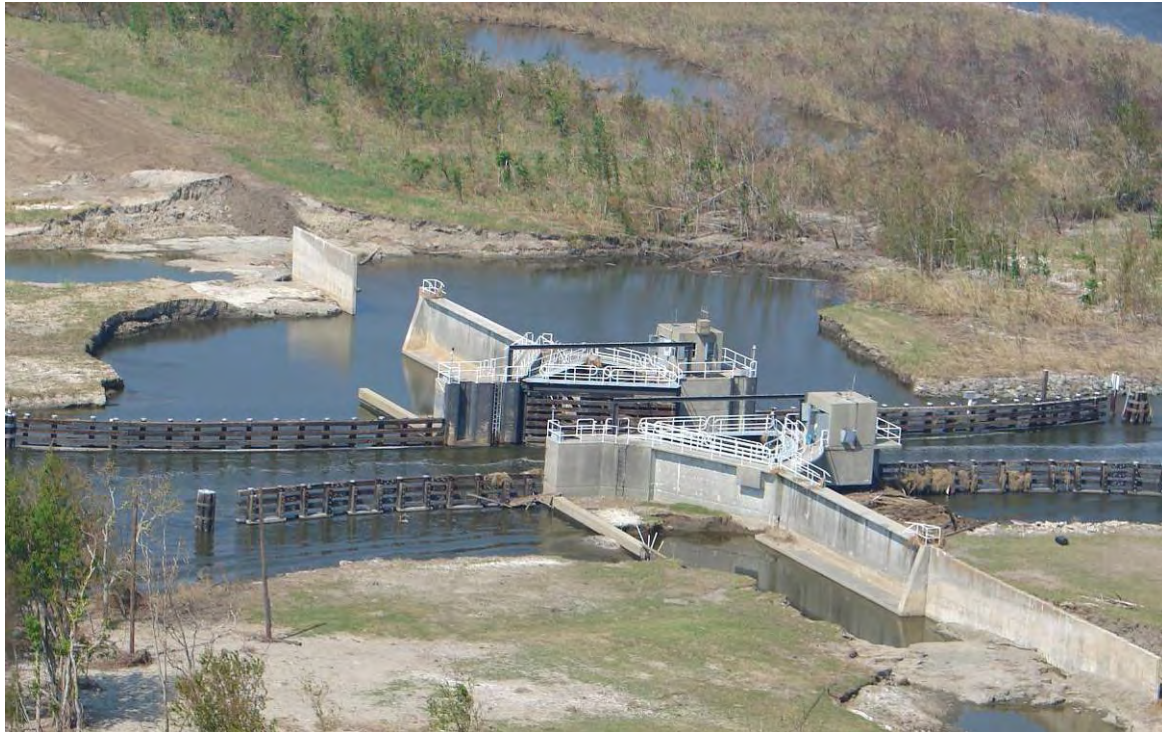
Figure 10.29: Control structure at Bayou Dupre (location 9 on Figure 10.6) suffered extensive scour and erosion during the storm surge and overtopping conditions associated with Hurricane Katrina.

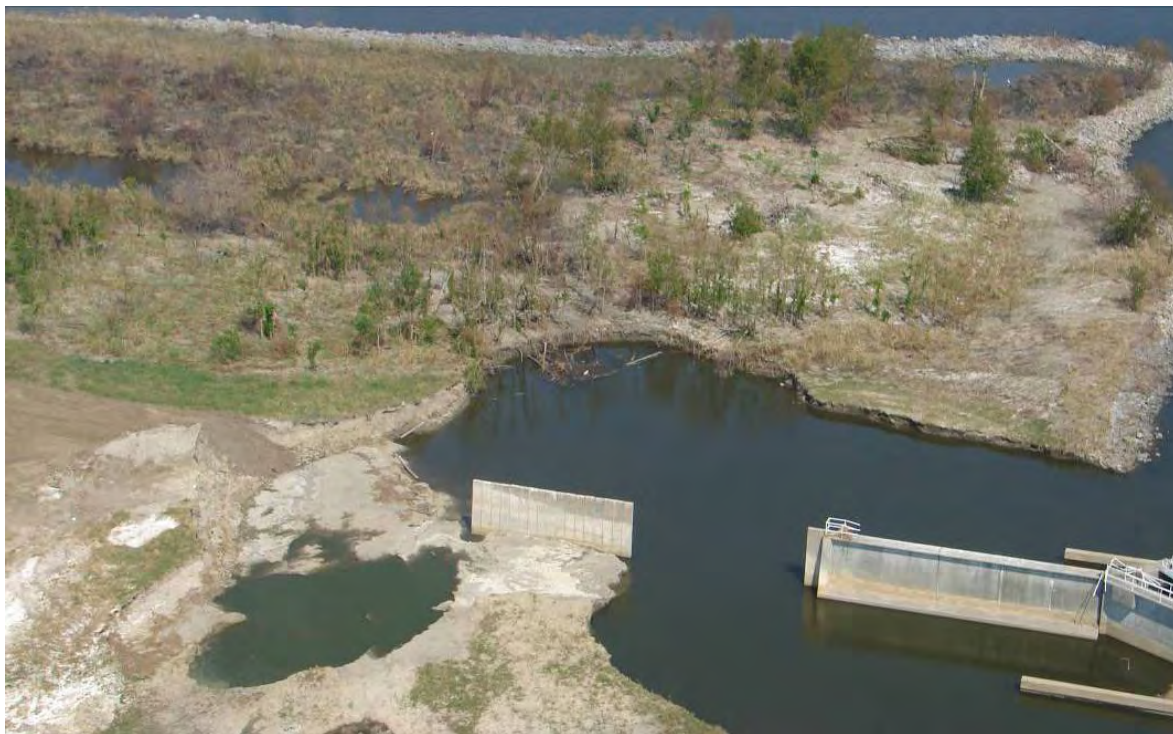
Figure 10.30: Another aerial photograph of the scour and erosion damage to the Bayou Dupre control structure.

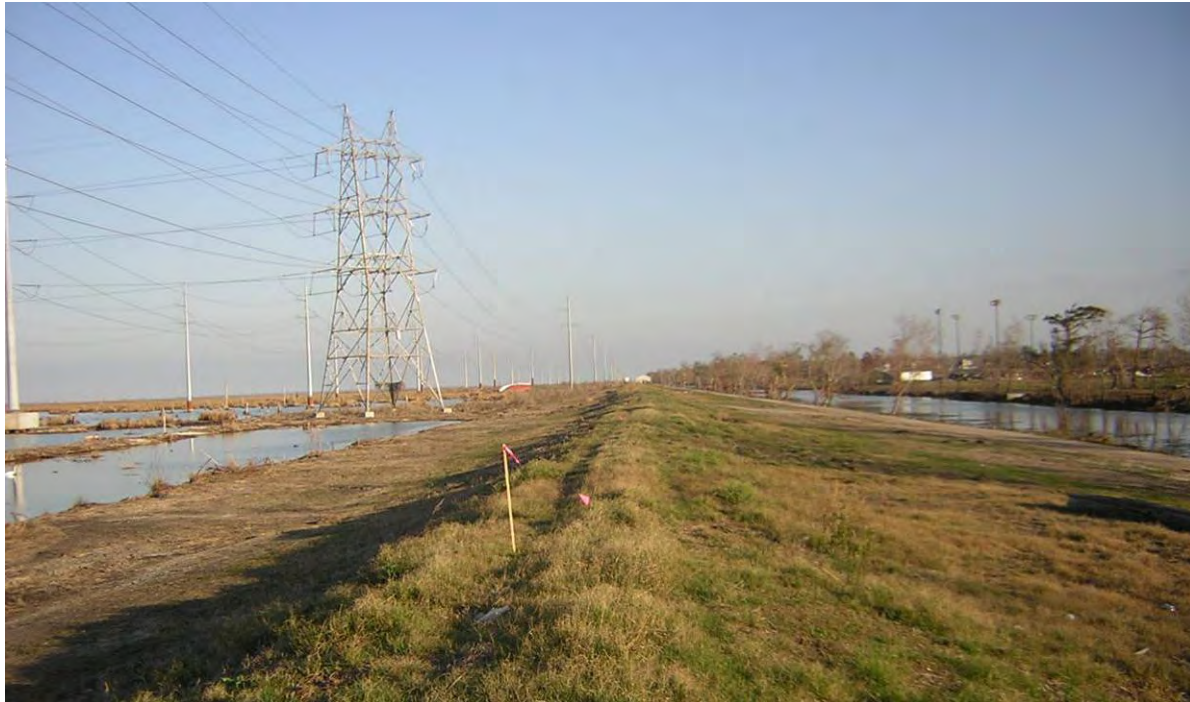
Figure 10.34: Eastward looking view of the secondary earthen levee (constructed to approximately Elevation +6.0 feet MSL) immediately to the north of the Corinne Canal, east of Paris Road (location 10 on Figure 10.6). This levee was significantly overtopped and did not experience significant damage.

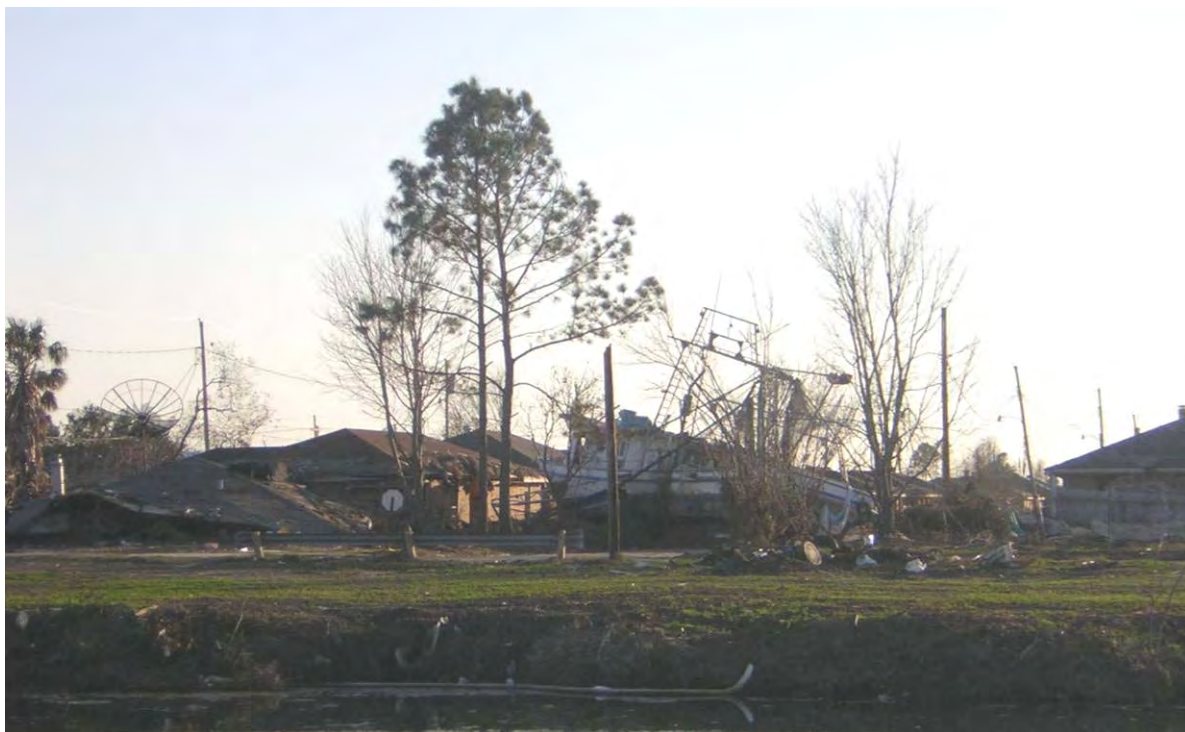
Figure 10.35: A fishing boat was washed over the levee shown in Figure 10.34 and landed in this Chalmette residential neighborhood within St. Bernard Parish.

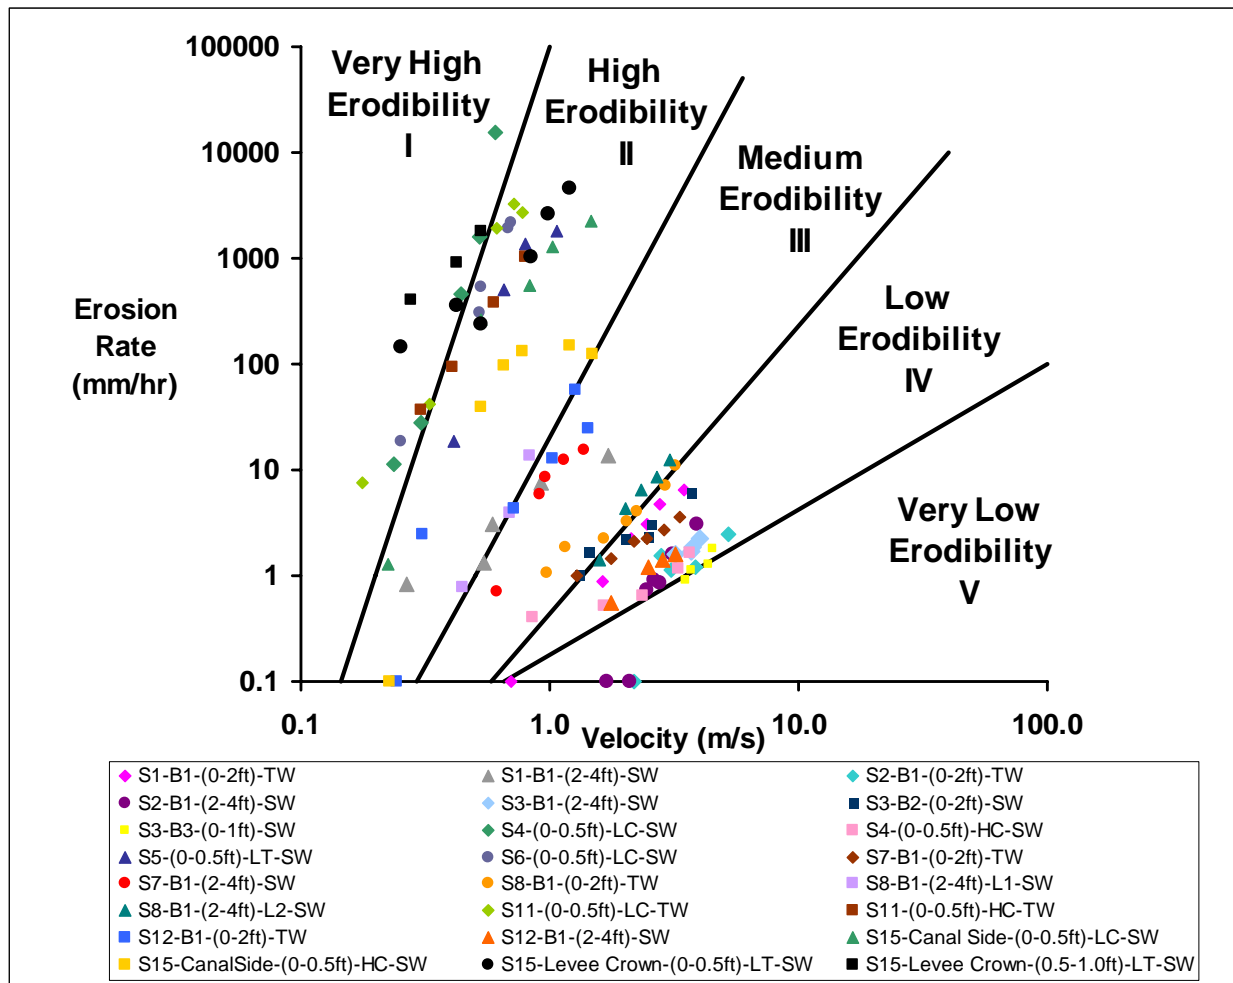
The erosion susceptibilities of all the samples collected are presented in Figure 10.41. The test result designations are based on the Site Number, the boring number at the site, the depth interval over which the sample was collected, and additional sample notes. Thus, a sample marked as S1-B1-(0-2ft)-TW indicates that the sample came from Boring 1 at Site No. 1 (Levee east of HWY 11 and North of HWY 90) from a depth of 0 to 2 feet below the crest of the levee.

Figure 10.41: Summary of all EFA test results. The test result designations are based on the Site Number, the boring number at the site, the depth interval over which the sample was collected and sample notes. The EFA test results indicate that the materials used in levee construction varied from very high to very low erodibility, which matched the observed performance of these levees.

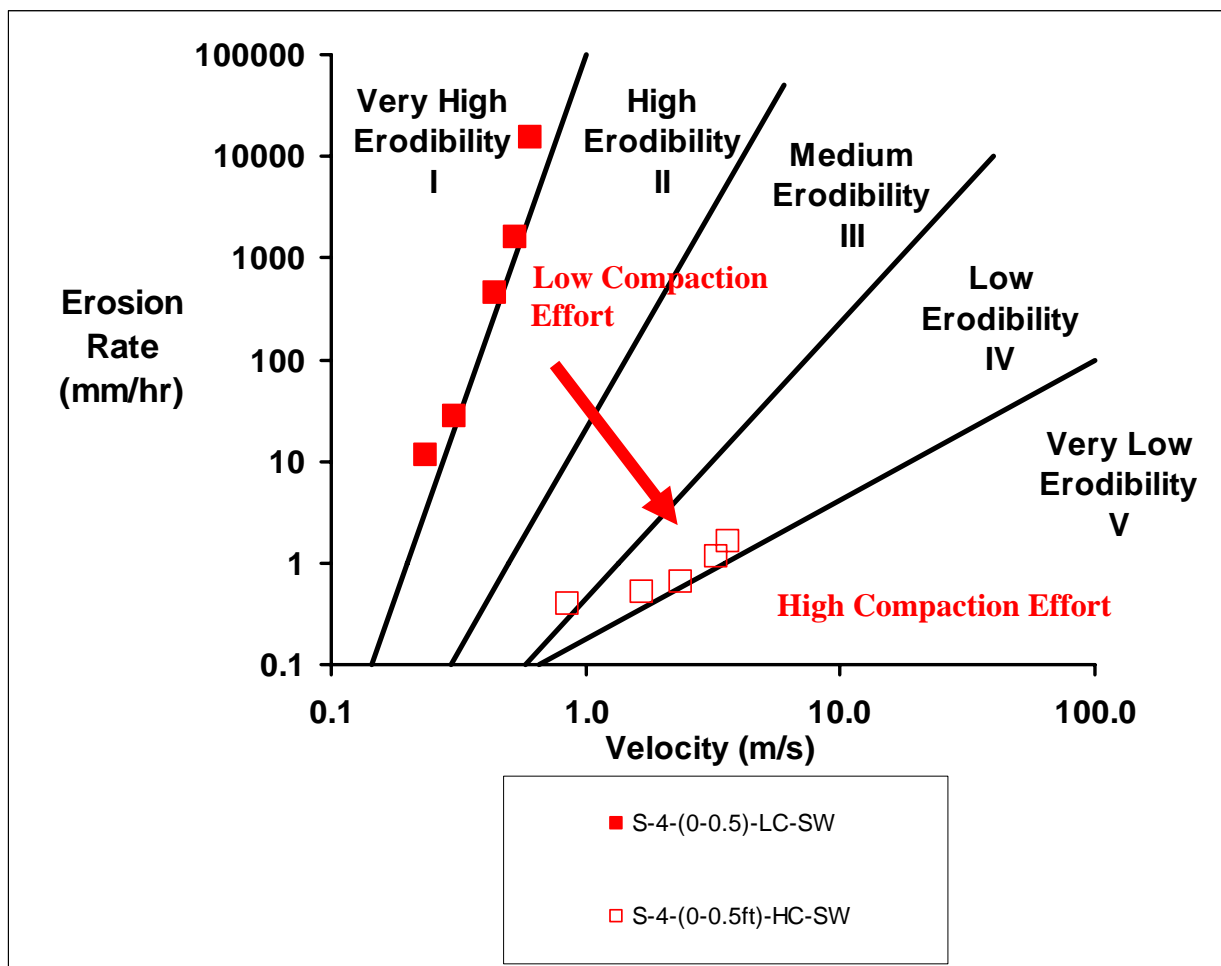
Figure 10.43 shows the dramatic impact proper compaction can have on the erodibility of some types of soils. Materials sampled from the MRGO levee were tested at two compaction levels: low compactive effort and high compaction effort. The corresponding results speak volumes to the importance of compaction in earthen levees. The low-compaction sample was found to be very highly erodible, whereas the high-compaction sample exhibited low erodibility characteristics. High compaction effort is based on 90-95% relative compaction per the Modified Proctor test (ASTM D1557).

Figure 10.43: Here materials sampled from the MRGO were tested at two levels of compaction. This figure shows the dramatic impact proper compaction has on the erodibility of soils. Materials sampled from the MRGO levee were tested at two compaction levels: low compactive effort and high compaction effort. The corresponding results speak volumes to the importance of compaction in earthen levees. The low-compaction sample was found to be very highly erodible, whereas the high-compaction sample exhibited low erodibility characteristics.

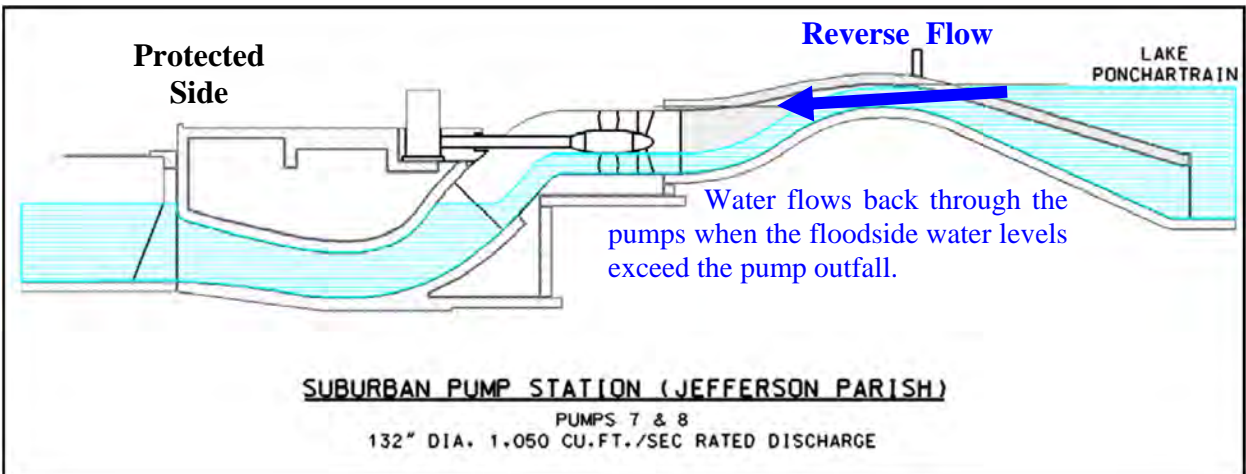
Figure 10.53: Performance of the pumping system (and causes of pumping capacity loss) during and after hurricane Katrina.

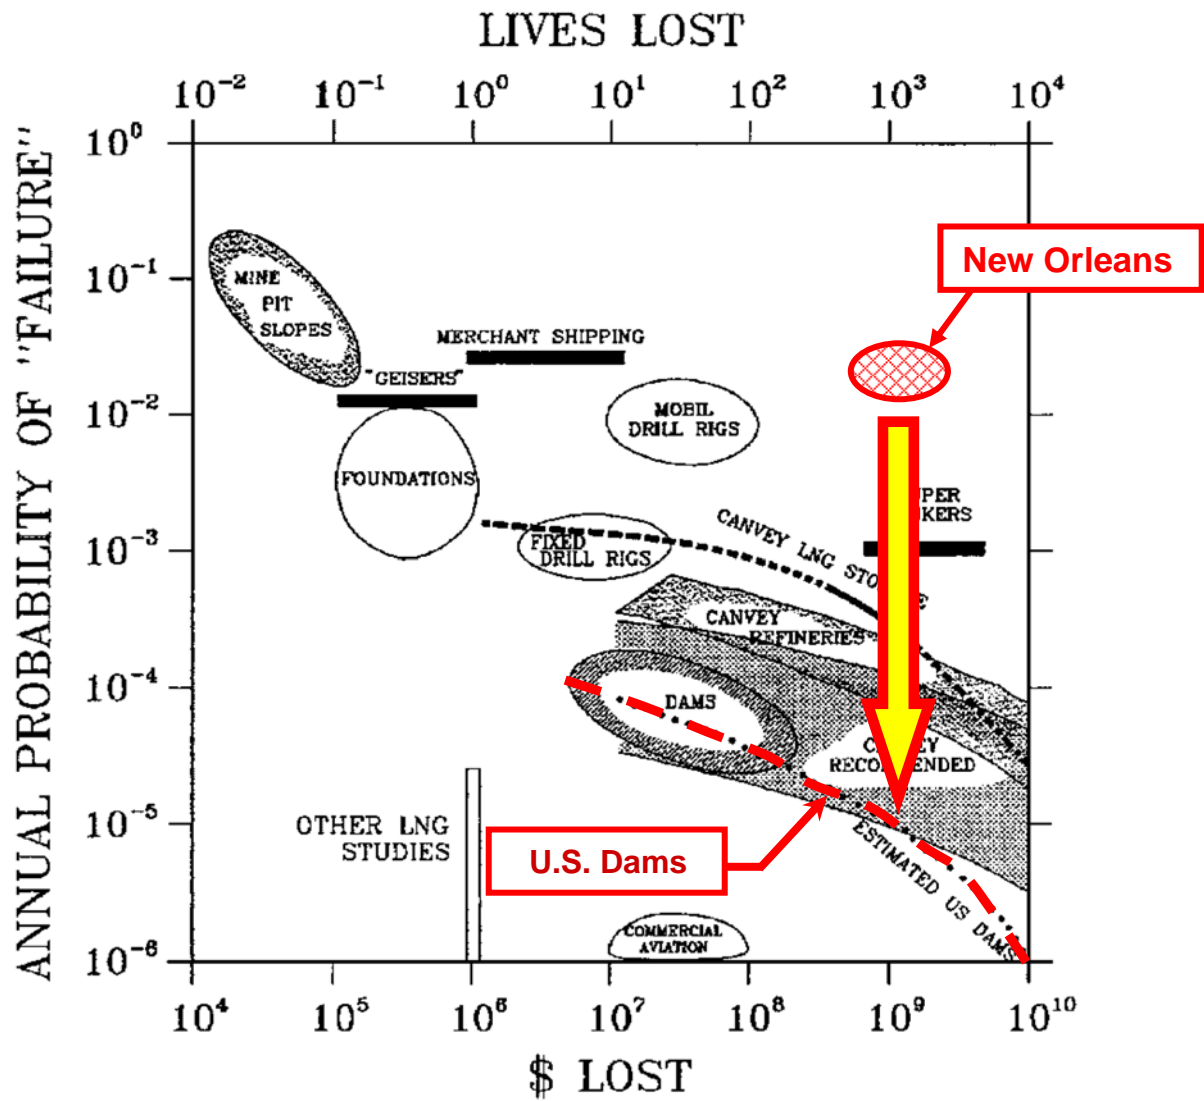
Also shown on this plot is our investigation’s view of the level of reliability associated with the New Orleans regional flood protection systems prior to hurricane Katrina. Our best estimate, based on information currently available, and given the targeted design levels and the flaws and vulnerabilities embedded in the system, is that the pre-Katrina system was likely to fail catastrophically approximately every 30 to 75 years. The cost of the failure (in hurricane Katrina) was on the order of \$100 to \$200 billion in losses, and approximately 1,500 lives were lost.

As indicated by the large arrow in Figure 11.1, the difference between the level of risk (or reliability) of the New Orleans regional flood protection systems and conventional U.S. dam practice is approximately three orders of magnitude; a factor of roughly 1,000 times safer and more reliable. Reliability is a function of two sub-elements: (1) the targeted level of

The New Orleans regional flood protection systems were never specifically targeted at any given level of reliability with regard to formal definition of storm levels for design (e.g.: the Standard Project Hurricane was never quantified as a “100-year storm” or a “300-year storm”, etc.), and this was a lapse, as it put the design of the regional flood protection system out of step with current practice. Our assessment in plotting the pre-Katrina New Orleans case in Figure 11.1 is that the system as it existed was likely to be failed by roughly the 30-year to the 75-year (average recurrence interval) storm.

Figure 11.1: Risk plot showing the estimated pre-Katrina risk associated with the New Orleans regional flood protection system, and customary risk levels for current U.S. Practice with dams.

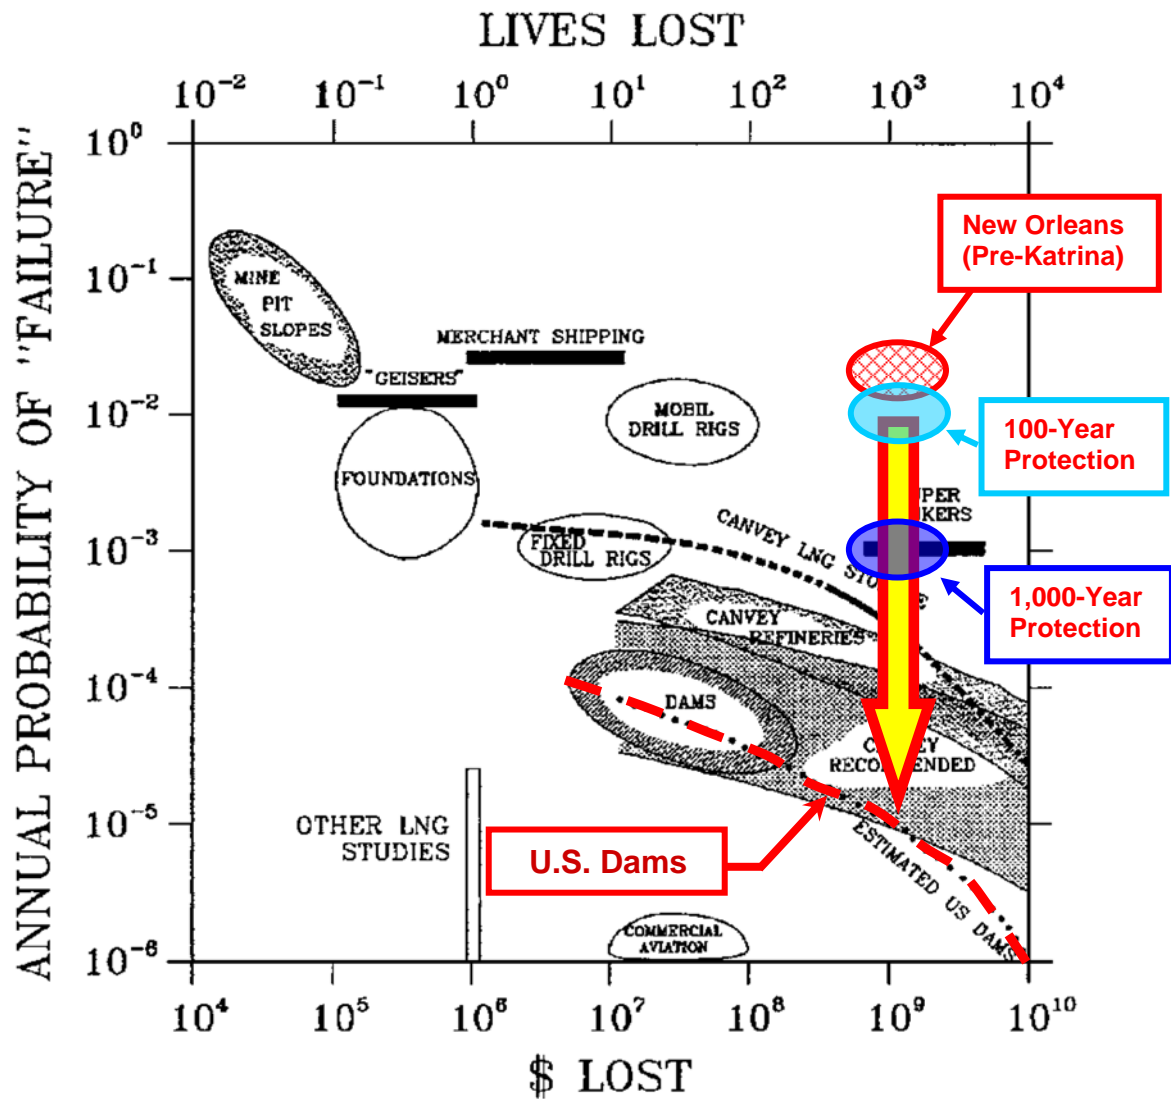
If the system is re-engineered to safely (successfully) handle a 100-year storm (storm loading likely to be exceeded typically once every 100 years), then the large red area of Figure 11.1 would move to the location shown by the light blue area in Figure 11.2. That would not bring the level of safety and reliability anywhere near to current U.S. practice for dams. Targeting a 1,000-year level of flood protection, and achieving that level, would result in the darker blue zone in Figure 11.2.

Figure 11.2: Risk plot showing the estimated pre-Katrina risk associated with the New Orleans regional flood protection system, and customary risk levels for current U.S. Practice with dams. Also shown are projected New Orleans risk levels for “successful” 100-year and 1,000-year storm and flood design.

28. ***Design standards, especially with regard to targeted levels of system reliability, need to be reconsidered (see Figures 11.1 and 11.2).** This is already underway; the USACE is performing a comprehensive re-assessment of design procedures and standards, and treatment of flood protection systems on a risk-based systems basis is anticipated to be an important element of this. That is a very promising development.*

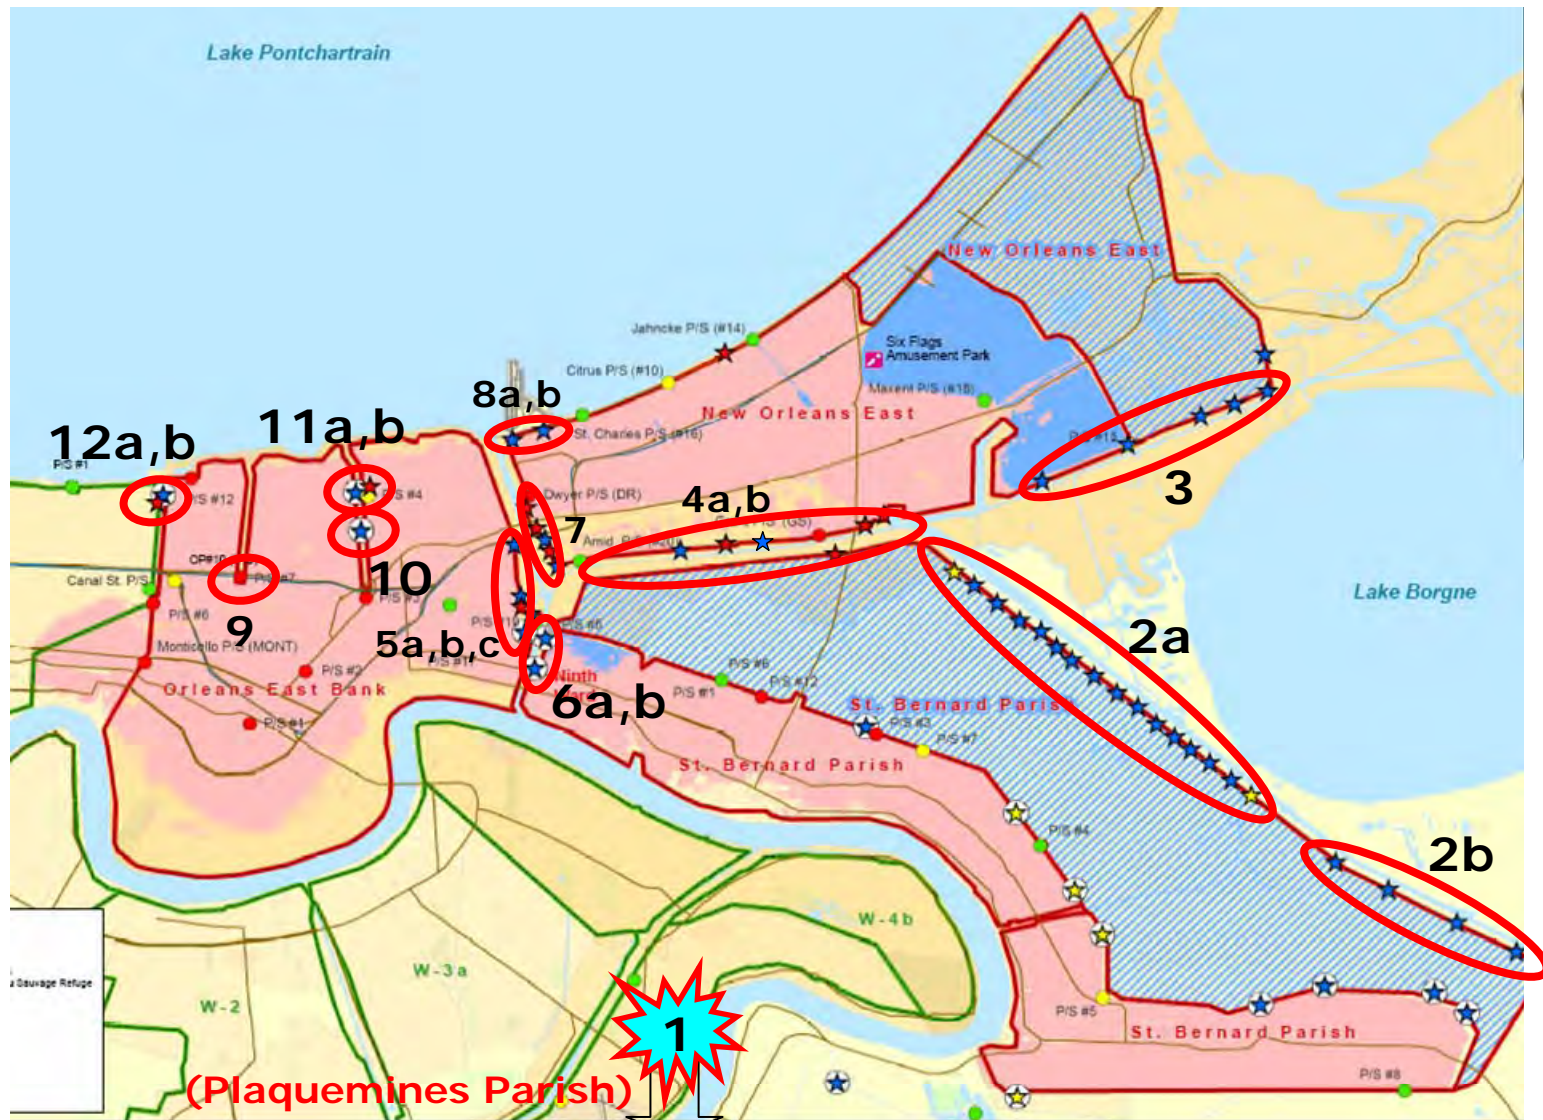
An additional set of partially developed erosional features occurred at a number of locations on the east bank of the IHNC at the west edge of the New Orleans East protected area. These are grouped together as “Site #7” in Figure 11.4 (and Table 11.1.) Overtopping occurred along much of this frontage, but the erosional distress systematically occurred at “transitions” between adjacent, disparate system elements (e.g. at transitions between full height earthen embankments and adjacent gated concrete floodwall segments, etc.) Here, again, it was transitions rather than the main segments themselves that proved problematic.

Figure 11.4: Summary of principal failures, breaches, and other locations of interest. (Blue stars mark breaches, red stars mark locations of distress.) [Base map provided by the USACE]
